AlbCad Design

Structural, Mechanical and Electrical Inspection Report

This **Structural Inspection Report** is made by **AlbCad Design** Inspector -----
for -----resident at -----.
Address of property inspected -----.

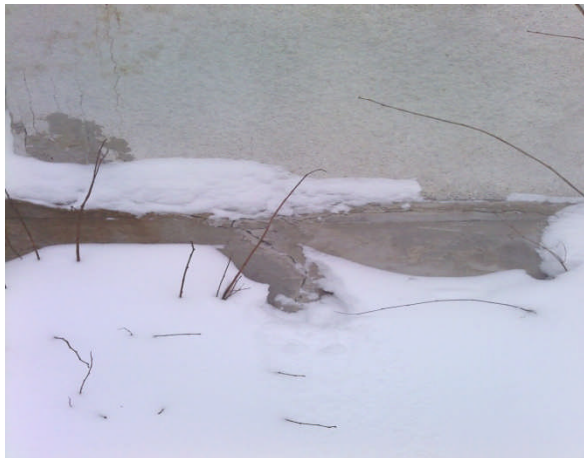
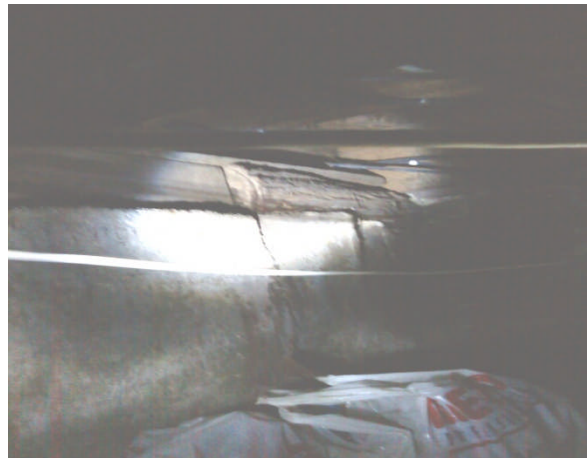
One of the most significant consequences of differential settlement observed was the no tolerable displacement of the exterior part of the foundation (spot marked with square round corners at the map) and this part falls under the extension at the rear part of existing of the building being constructing like closed balconies with exterior wall timber wood construction and exterior brick.

The displacement of entire structure going down at one of the corners as more than couple of inches and the foundations right under this part of the structure is moving down with a very obvious crack, showing clear a cut at the foundation. As the building ages, it is probable the foundation will continue to experience differential movement, regardless of how well it was constructed or its present condition. This differential movement does not stop as buildings become older; older structures with a history of minimal differential movement have been known to develop foundation problems in a very short time due to changing conditions at the perimeter of the building foundation.

To stop the displacement of the broken foundation and further sink of entire structure on top of it the need for repair is immediate. Concrete resistance piercing or underpinning method can be used to

stabilize the foundation from sinking further into the ground. Push piers and helical underpinning methods offer the ability to not only stabilize, but also to lift the structure. The foundation underpinning systems guarantee to prevent the building from further movement. Concrete underpinning is used in heavier structure for stabilization. A hollow caisson is driven into the ground and filled with concrete to support the structure. This method offers more strength than helical underpinning. Concrete underpinning, however, does not offer the ability to lift the structure in anyway. The cost of the stabilization for the given could be according to our opinion around 16 000Can but for more accurate estimation contact e specialize contractor in foundation stabilization.

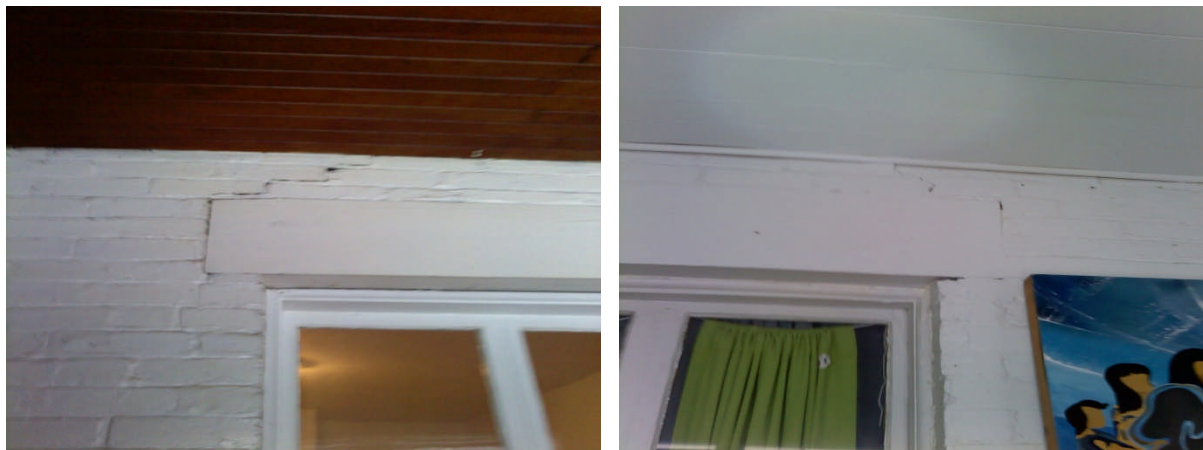
The most significant major irregularities of the structure observed was the displacement of the foundation at the location round corner square spot at the map and the entire structure displacement on top of this part of the foundation. The floors on this part are obviously down at least more than couple of inches. This sinking down structure have caused other problems in the masonry envelope and some cracks on the exterior brick veneer as well.

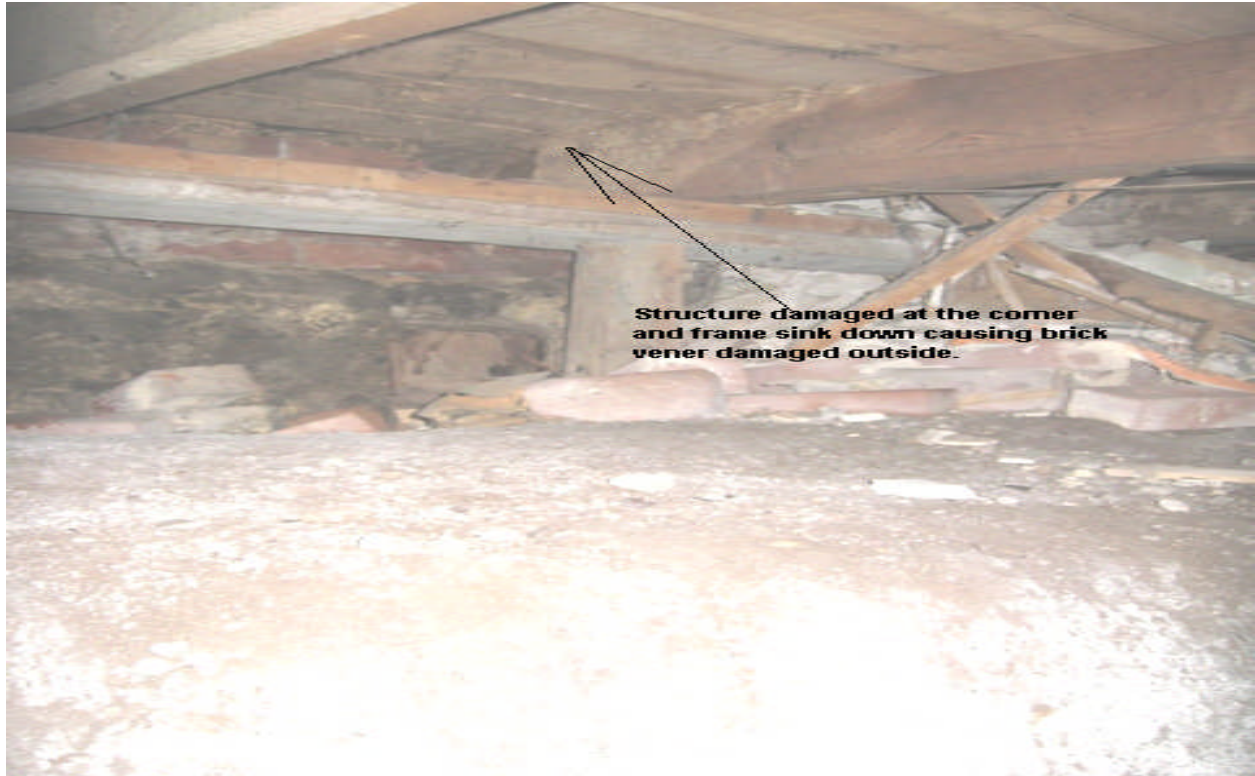
The most significant masonry irregularities observed was at the corner with location with square spot at the map. The corner was chipped off the concrete grade beam of the foundation which is usually caused by differential settlement that has caused shearing between the brick veneer. Chipped corners indicate structural frame differential settlement down, but there is no need for foundation repair

because of the chipped corner but the structure of the frame at the corner has to be rebuild. Most of the masonry of entire corner on this location has to be redone after the structure stabilization.

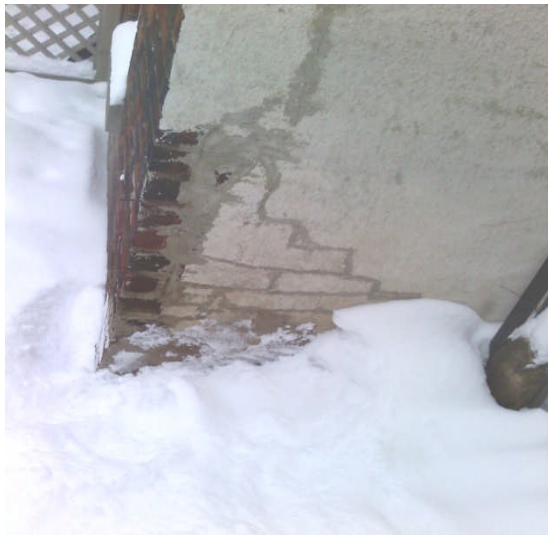
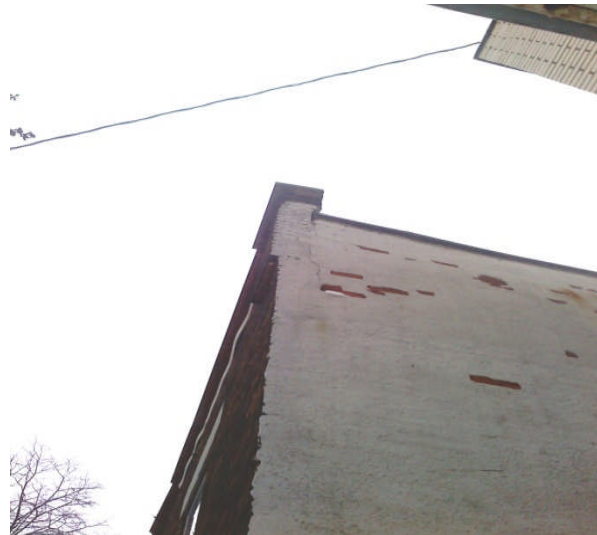
The walls over the ceiling of the second floor looks not to strait and this is a sign of the frame deformation on top of the building.

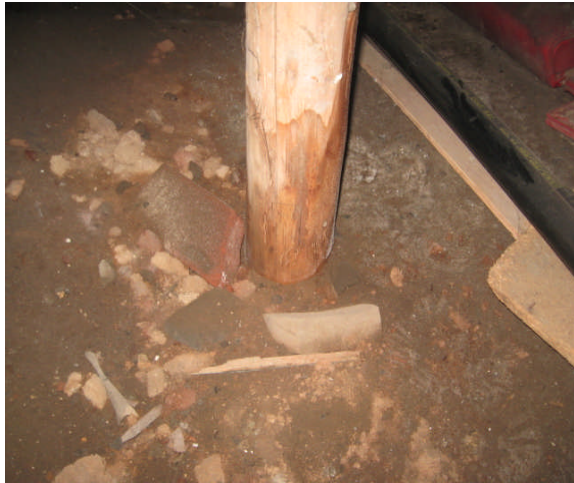
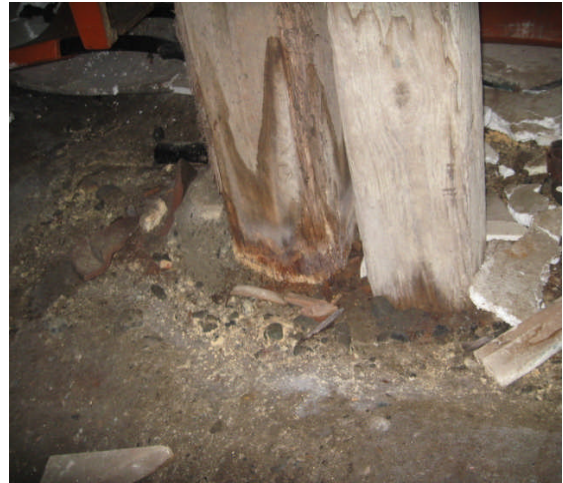
Wood-destroying insect vulnerability and humidity was observed at all the columns holding the main beams under the first floor and this should be cause for further destabilization in the future years of the

structure over it. Some minor framing irregularities were observed that should have no significant effect on the performance of the building.

There were no observations made that would indicate that the basic structure of the building, including load-bearing walls and other framing members, was in need of immediate repair or was not performing adequately at the time of inspection but improvement and replacement of the columns has to be done in the near future.

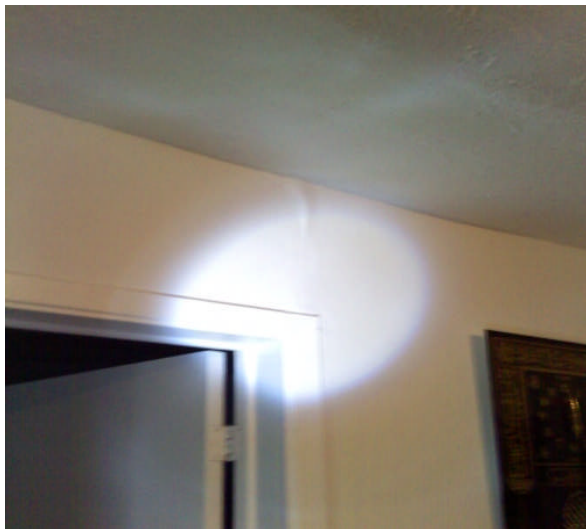
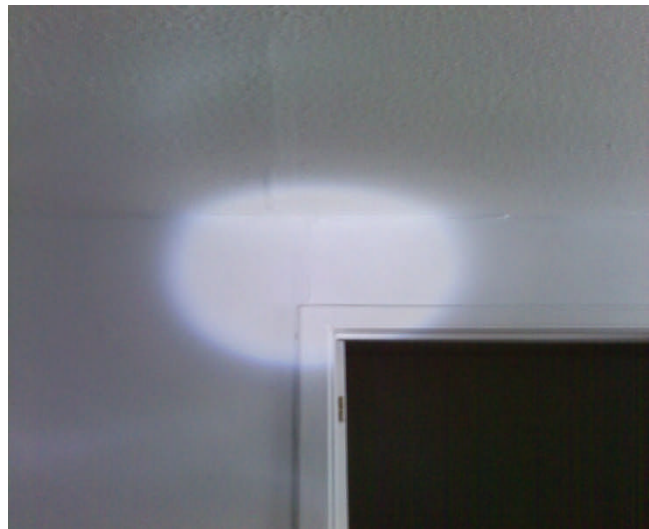
The sheetrock floating material had popped off in some places and this sometimes happens when there is foundation movement causing the sheetrock to shear against the wood framing of the building.

Sheetrock cracks above doors, windows, and in the ceiling, usually associated with differential settlement, were observed in the several locations and most significant several outside masonry cracks close to the windows

The cost of the improvement and necessary reparation in the structure including masonry could be according to our opinion around 12 000Can but for more accurate estimation contact e specialize contractor in structure stabilization.

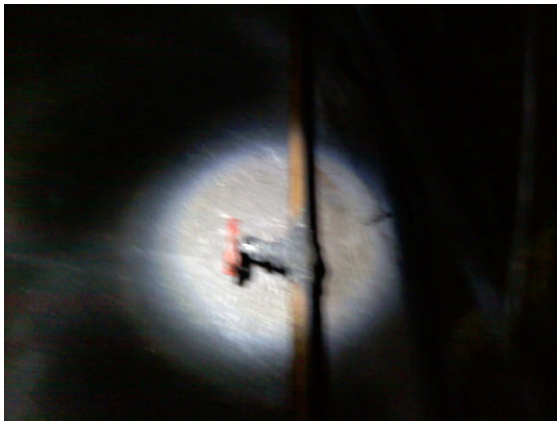
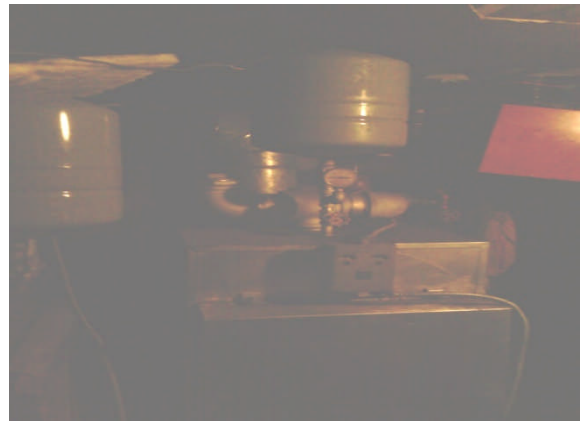
Where visible water distribution plumbing was observed to be fabricated from copper. The plumbing connected with hot water tank and to the hot water heating system was fabricated from galvanize pipes with clear spots of rusts .

The main water service shutoff valve was located at the crawlspace. It was operated by inspector and results that it was in working condition.

Water inlet lines to the building should be insulated to prevent them from freezing during the winter.

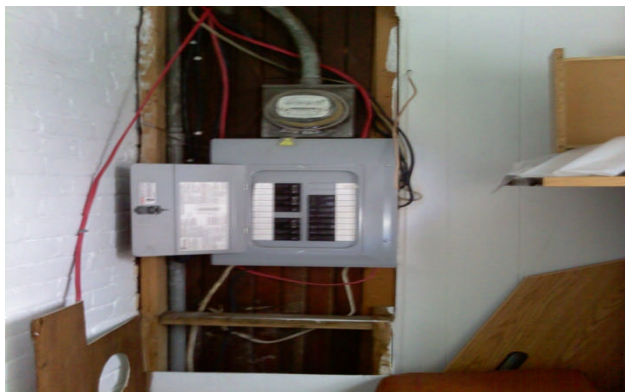
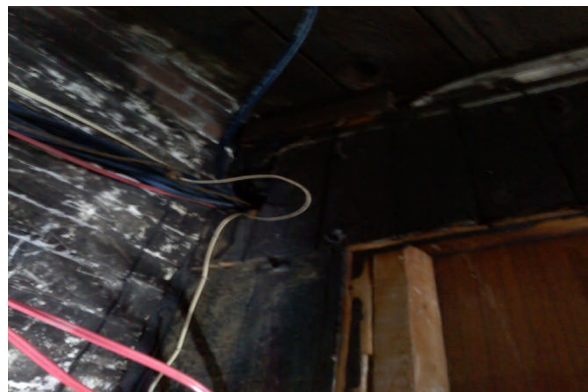
Breakers panel box

No bonding strap was observed at the breaker panel box between the main ground buss and the panel box to provide a ground for the panel box. Bonding straps are currently required, but there is no requirement for the equipment to be upgraded unless there is a major renovation of the electrical system. Some of the knockouts at the bottom of the panel box were pushed out, partially, leaving gaps. It is normally desirable for the knockouts to be in good conditions to help retain a fire that might start in the panel box from spreading to the wall cavity.

An previous fire was detected at the same place of existing Breaker Panel Box. The new circuit Breaker Panel Box was placed but still is obvious some wiring and over the capacity of the panel. Aluminum wiring as detected to be the main electric distribution system interior. Proper electrical repair by an expert is very important to reduce the hazards of aluminum wiring in homes. Aluminum wire connections can overheat enough to start a fire without ever drawing enough current to trip a circuit breaker. The cost of the updated the electric system and reparation of the deficiencies mentioned above according to our opinion around 10000Can but for more accurate estimation contact e specialize electric contractor.
