AlbCad Design

Passerelle Inspection Report

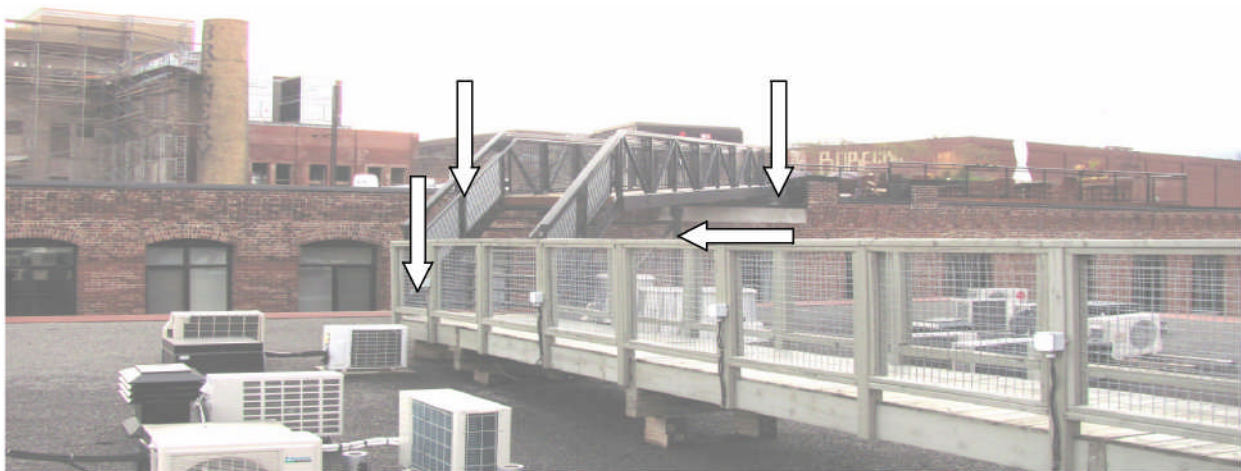
Picture 2

Part of this report is observations and opinions /recommendation section. The opinions section is intended to provide an opinion of the actual situation of the Steel Structure Passerelle mentioned above as it is today October 05, 2010. The Passerelle sits in both sides of each building by means of steel frame supports and indicated by arrows in the Picture 2.

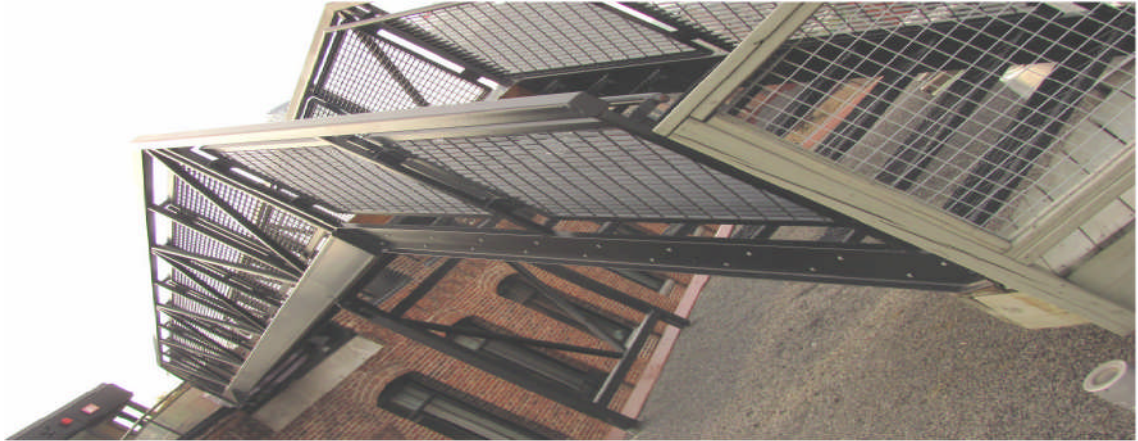
Picture 3

The passarelle sits in the lower side over steel frame support (Picture 3) made with steel angles and sitting on the edge of the flat roof of the building over side supporting wall. From carefully visual inspection of the support it result that it is in good condition, not any sign of any footing displacement or any other crack near them which may indicate the start of any existing or near future performance problem. The state of the steel frame seems to be in good condition and fully painted and no sign of any steel deterioration because of the rust. The joints of the steel frame support fully in good working condition with no sign of rust or any part loose as well.

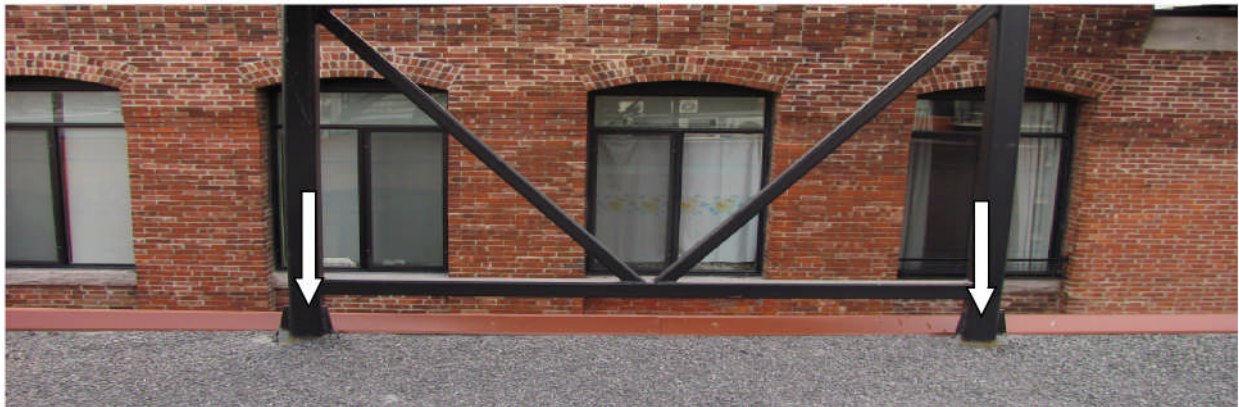
Picture 4

The welding joint of passarelle stairs (Picture 4 ,5,6) with the body are performing good and no any sign of crack or loose part.

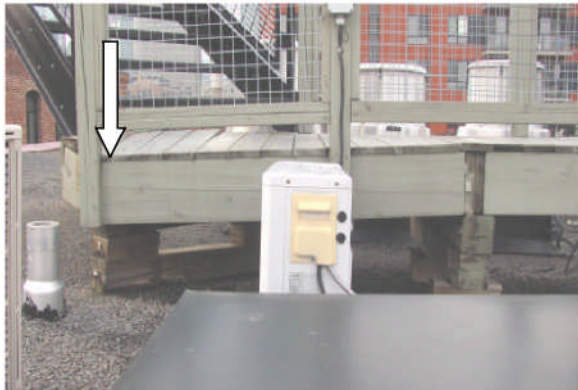
Picture 7

The passarelle stairs landing over the treated wood sidewalk structure (Picture 7 & Picture 8) seems to experience some damages and shifting down at one corner as it shown by indication arrow in the picture. The cross wood support under the wood frame structure of sidewalk doesn't holds both sides of the frame and the side which doesn't sit over the support counts displacement down living the entire frame of the stairs with not a good support at the landing edge and as for result the stairs are being little bit loose. **It is very strong recommended the end of the sidewalk structure to be repair and the support under it to be replaced with the new one long enough to support both sides of the sidewalk frame. At the contact line of the stairs at the wood deck it is a good practice to have a bolt connection and it will be shown and detailed at the engineering repairing plans of the structure.**

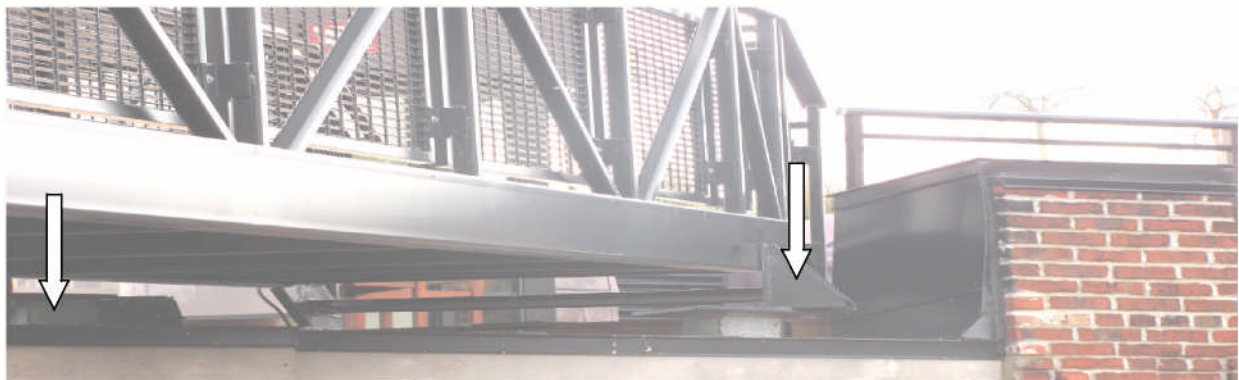
Picture 9

The supports of the stairs in the higher part seems also performing good and there is not any sign of cracks, displacement or other indications around them and the holding wall under (Picture 9 ,10,11).

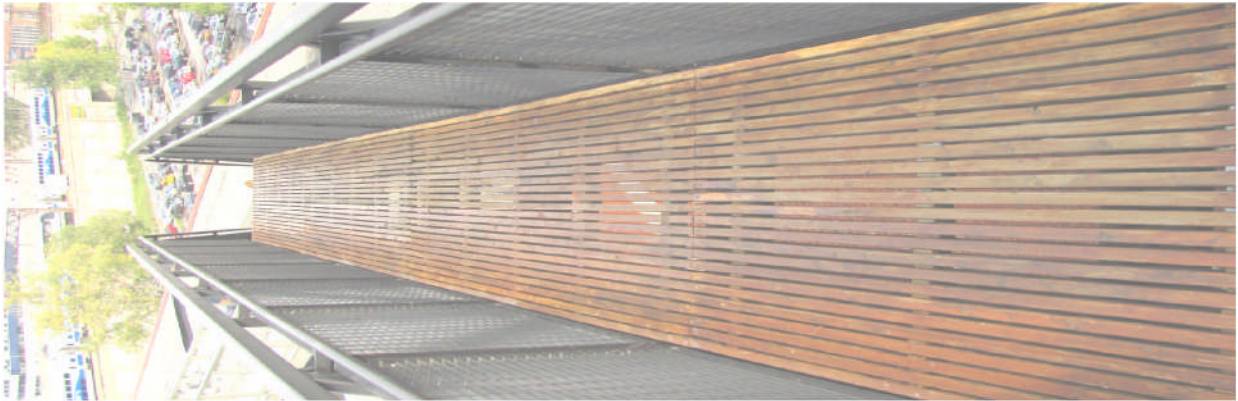
Picture 12

The deck of the passarelle itself its performing well and only some cracked wood strips identified as for the pictures below (Picture 12,13,14) need replacement in the near future.
