AlbCad Design

Passerelle Inspection Report

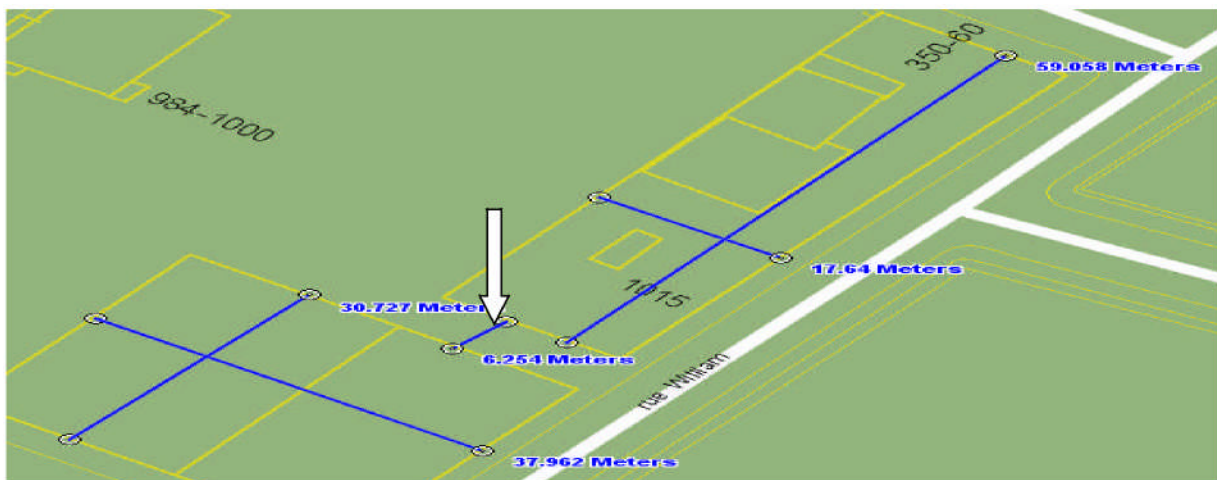
Picture 1

This Steel Structure Passerelle Inspection Report made today _____ by AlbCad Design, P.Eng. _____ at property (_____) actually connecting two separate buildings and location as for the picture below.
